## REL TAM Panel - Twin (Part Number: 250-00103)

### Certification

# Penetrant System Monitoring Panel Documentation

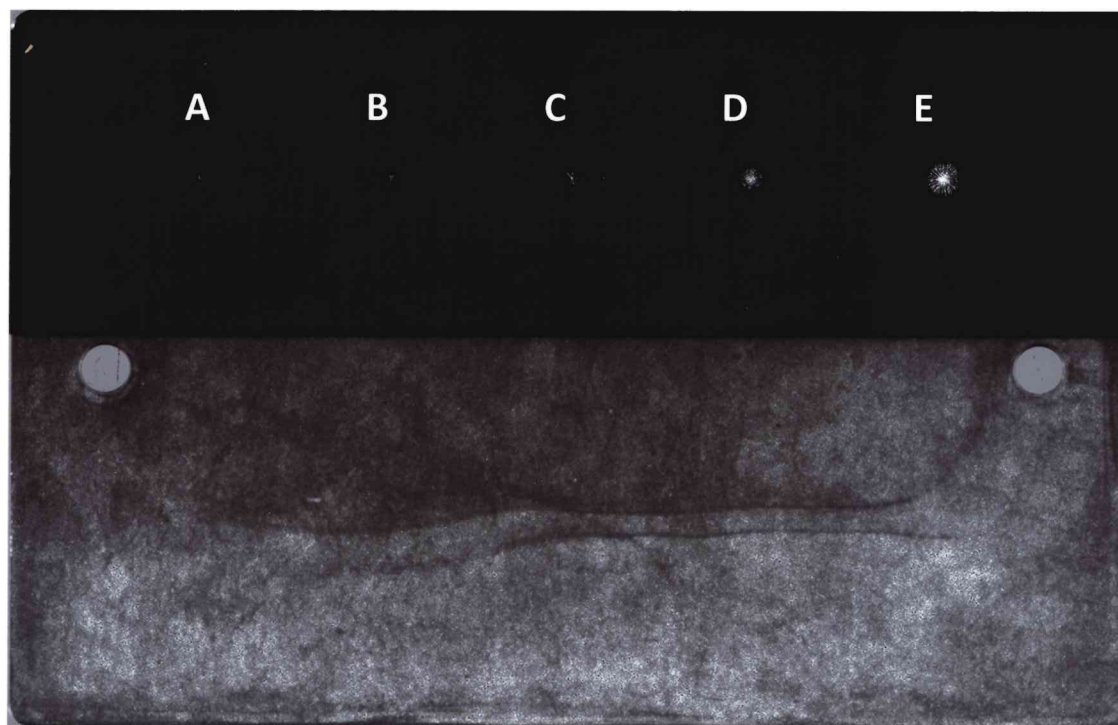
SN# 290778-087\_A

| Crack Position | A | B | C | D | E |
|---|---|---|---|---|---|
| Measured Size (Inch) | 0.028 | 0.055 | 0.082 | 0.151 | 0.222 |
| Specification (Inch) | 0.015 - 0.031 | 0.046 - 0.062 | 0.075 - 0.093 | 0.125 - 0.171 | 0.180 - 0.250 |

| Crack Depth | .0025" ± .0001" | 63 µm ± 2.5µm |

This photo is actual size. (1:1)

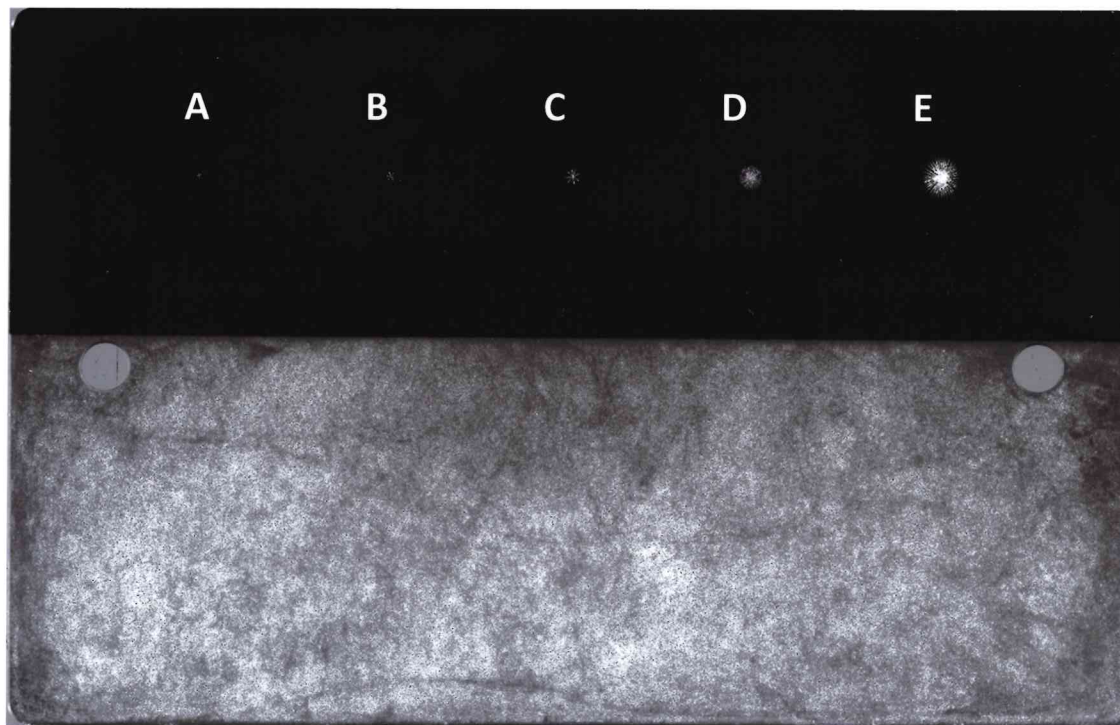
SN# 290778-087\_B

| Crack Position | A | B | C | D | E |
|---|---|---|---|---|---|
| Measured Size (Inch) | 0.031 | 0.062 | 0.091 | 0.160 | 0.238 |
| Specification (Inch) | 0.015 - 0.031 | 0.046 - 0.062 | 0.075 - 0.093 | 0.125 - 0.171 | 0.180 - 0.250 |

| Crack Depth | .0025" ± .0001" | 63 µm ± 2.5µm |

This photo is actual size. (1:1)
